## Preliminary Analysis Report

Bryson v. Rough Country, LLC

Mecanica Case Number: 22-3104

Date of Collision: March 15, 2020

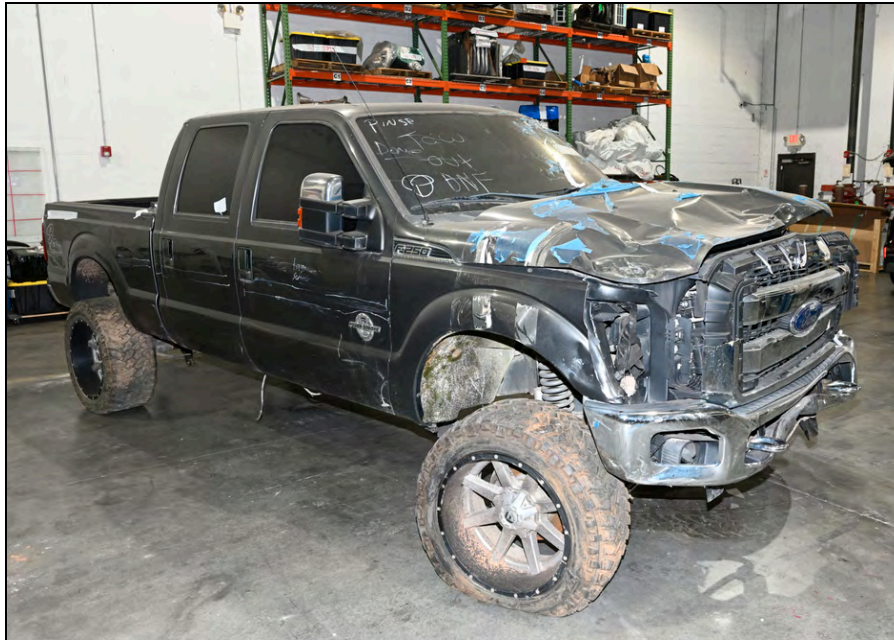
The right side of the vehicle had two horizontal scratches from the front of the right-front door to the rear of the right-rear door (**Figure 7**). However, these scrapes could not be clearly seen in the police photos (**Figure 8**) and there appears to be dried mud sprayed up over them, indicating they likely did not come from this incident.

**Figure 7: Right front of Ford F-250 showing scratches on right side of vehicle**

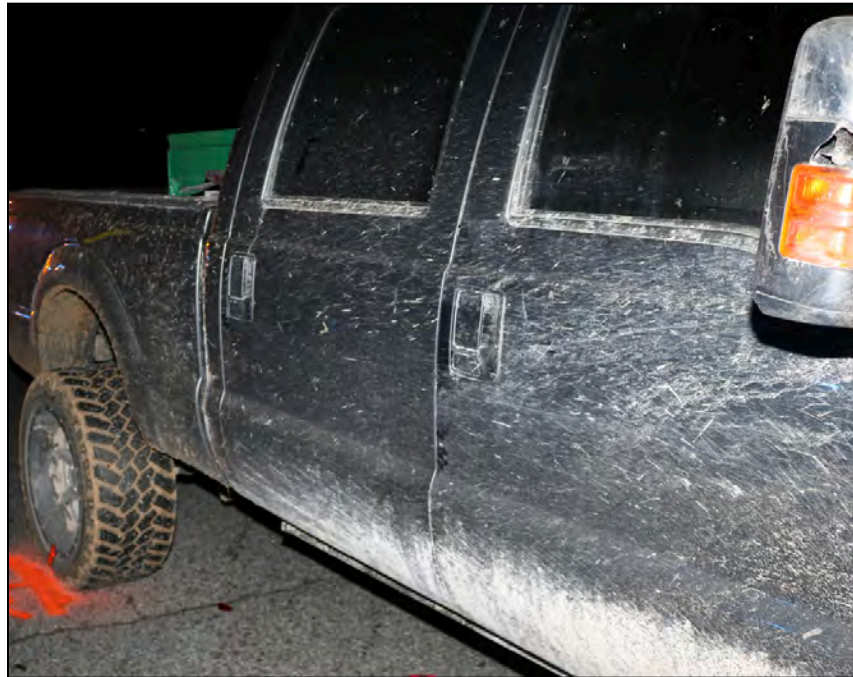
**Figure 8: Police photo showing no scratches on right side of vehicle**

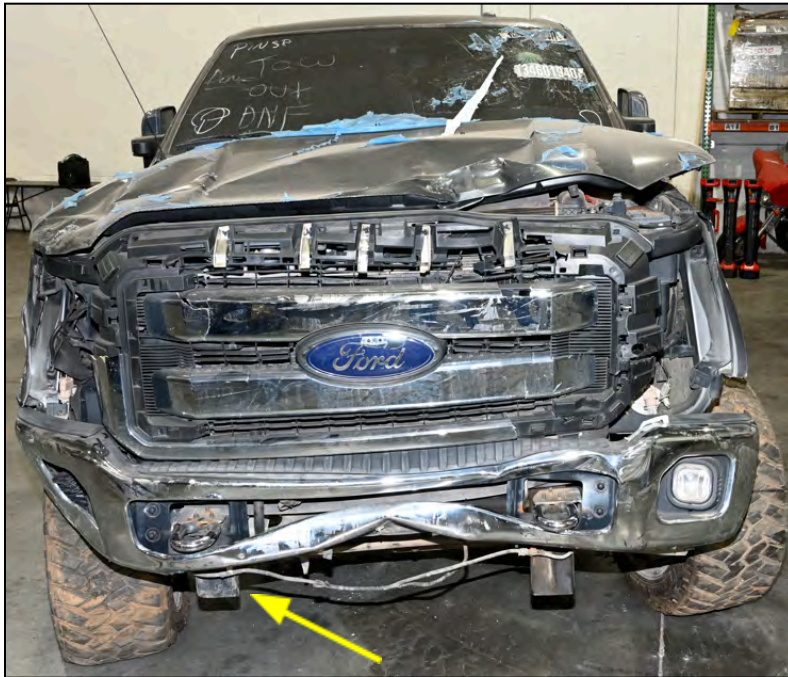
The bottom of the right Secondary Energy Absorption System (SEAS) was displaced rearward, see **Figure 9**. The left SEAS is angled with the bottom portion slightly forward. The left side of the windshield was fractured. The left edge of the front bumper is rotated downward. The left

**Figure 9: Front of Ford F-250 - right SEAS bracket displaced rearward**

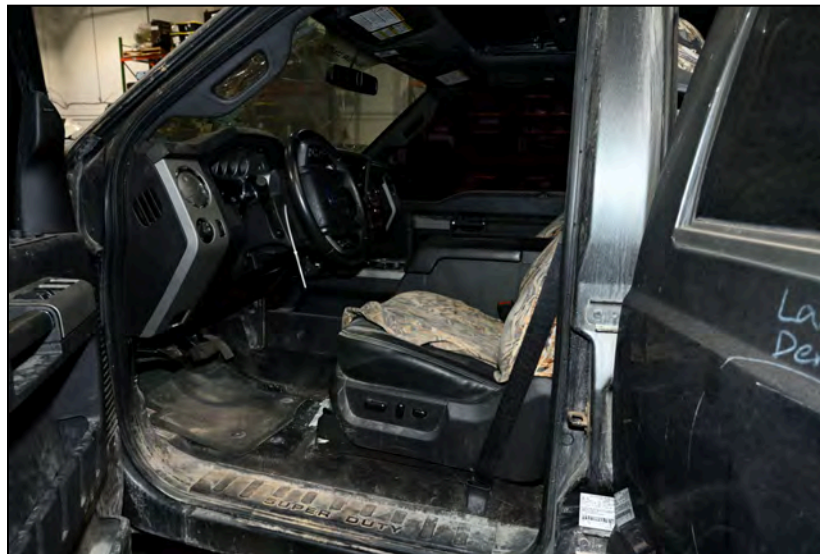
The Deployment data from the CDR report indicated the maximum longitudinal delta-V as -18.21 mph and the maximum lateral delta-V as -0.76 mph. Mr. Buchner reported the last longitudinal and lateral delta-Vs in the respective tables. Although these were the last values in the respective tables, they are not the values at the end of the event. 49 CFR 563 states, the end of event time is the moment at which the cumulative delta-V within a 20 ms interval becomes 0.5 mph or less. For this crash, the end of the event was approximately 141 ms after Time 0. At 141 ms, the longitudinal delta-V was -17.48 mph and the lateral delta-V was -0.40 mph. Based on these delta-Vs, the Principle Direction of Force (PDOF) was from approximately 12 o'clock.

**Figure 23: Front occupant area of F-250 showing the airbags did not deploy in this crash**

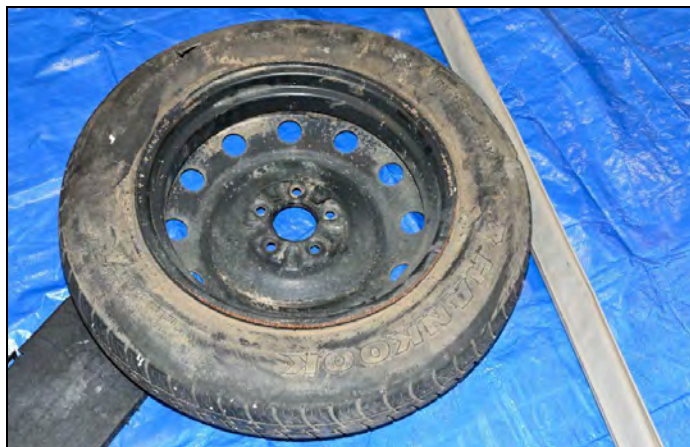
There was damage to the inner wheel flange of the spare tire consistent with the damage mentioned by Mr. Buchner (**Figure 24**).

**Figure 24: Damage to the spare tire wheel of the Escape**

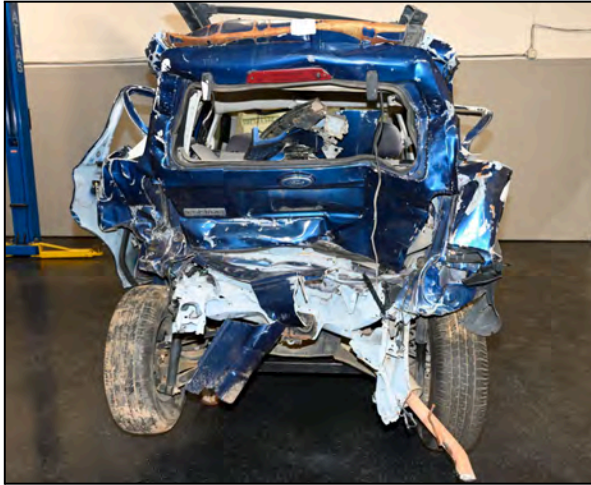
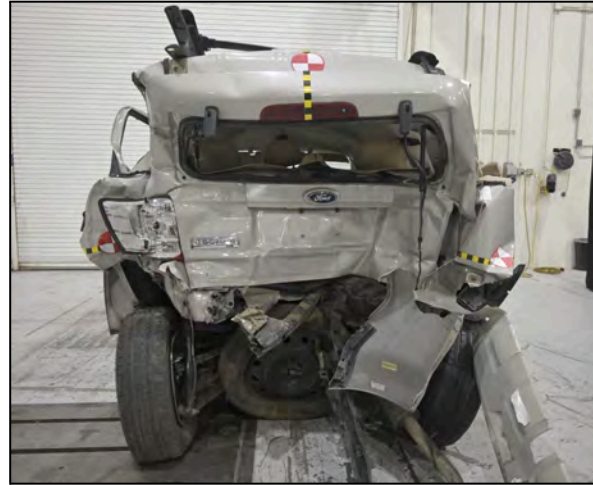
The damage to the test Escape was slightly different than the subject Escape. This was expected due to the differences in the subject and test F-250 equipment (**Figures 35 through 37**). There were also significant similarities between the subject and test Escapes. The C-pillars and D-pillars were both displaced forward, the top of the rear lift gate was rotated downward, the crease in the rear tailgate was below the right rear-window hinge.

**Figure 35: Rear view of the subject Escape (left) and test Escape (right)**

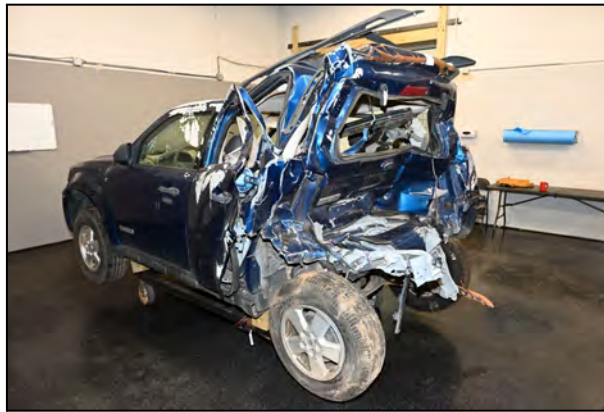
**Figure 36: Right-rear view of the subject Escape (left) and test Escape (right)**
